Sh.M. Nugumanova, A.E. Starikova, M.A. Nortseva

*Ye.A. Buketov Karaganda State University, Kazakhstan
(E-mail: starikova.anna.bgf@mail.ru)*

Analysis of the vegetation cover status of the city of Karaganda

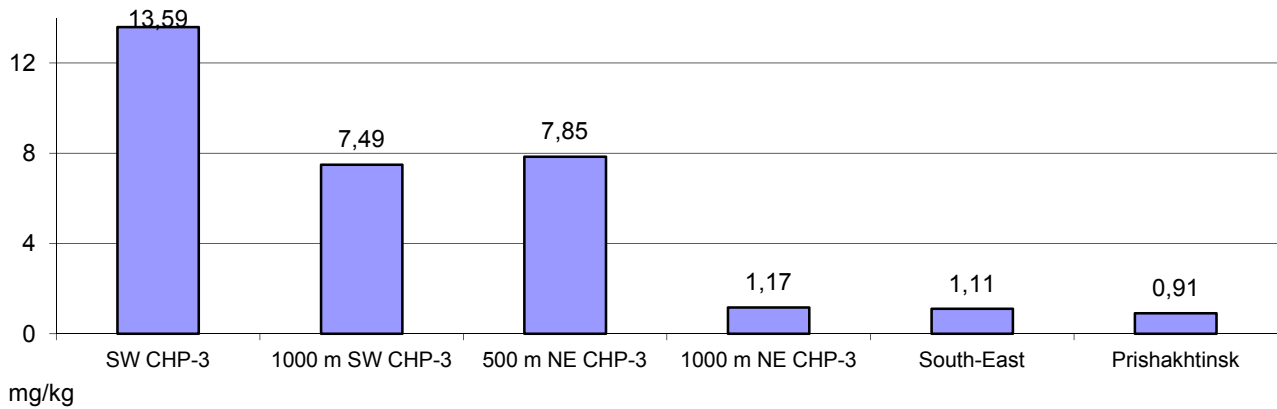
Figure 1. Nickel content in areas of Karaganda

The analysis of nickel content by areas of Karaganda is shown in Figure 1. Thus, in Maykuduk, 500 m south-west of CHP-3, the nickel concentration was 13.59 mg/kg, 1000 m south-west of CHP-3 — 7.49 mg/kg, 500 m north-east of CHP-3 — 7.85 mg/kg, 1000 m north-east of CHP-3 — 1.17 mg/kg. In the South — East and Prishakhtinsk, nickel concentrations were within the normal range.

Nickel exceeded in Maykuduk, 500 m to the south-west of CHP-3 amounted to 3,397 MPC, zinc — in Maykuduk, 1000 m north-west of CHP-3 to 1,554 MPC, cobalt — in Finskiy settlement to 7.32 MAC, iron — in Maykuduk, 1000 m north-west of CHP-3 at 27 MPC (Table 1). The source of environmental pollution by nickel was mining enterprises, thermal power station and motor transport.

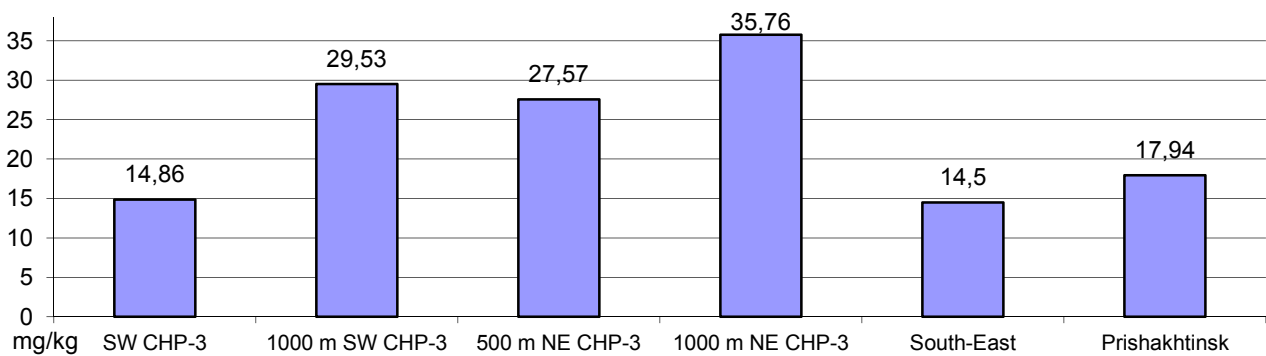
Figure 2. Zinc content by areas of Karaganda

Analysis of the zinc content showed (Fig. 2) that in Maykuduk, 500 m south-west of CHP-3 — the concentration was 14.86 mg/kg, 1000 m south-west of CHP-3 29.53 mg/kg, MPC 23 mg kg, 500 m to the north-east of CHP-3 — 27.57 mg/kg, 1000 m to the northeast of CHP-3 — 35.76 mg/kg. In the South-East and Prishakhtinsk, nickel concentrations were within the normal range. Zinc is the least toxic of all the heavy metals listed above. However, all elements become toxic if contained in excess; zinc is no exception. The physiological effect of zinc lies in its action as an enzyme activator.

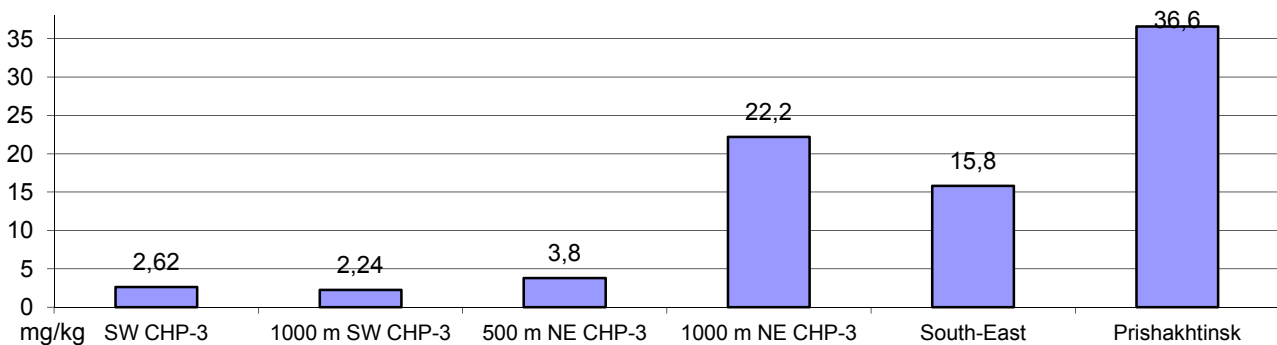
Figure 3. Cobalt content by areas of Karaganda

An analysis of the cobalt content (Fig. 3) showed that no excess of cobalt was detected in Maykuduk, with the exception of the area located 1000 m to the northeast of CHP-3, and was 22.2 mg/kg. In the South-East, on Shakhterov Avenue, the cobalt concentration was 15.8 mg/kg, in Prishakhtinsk, Finskiy, 36.6 mg/kg.

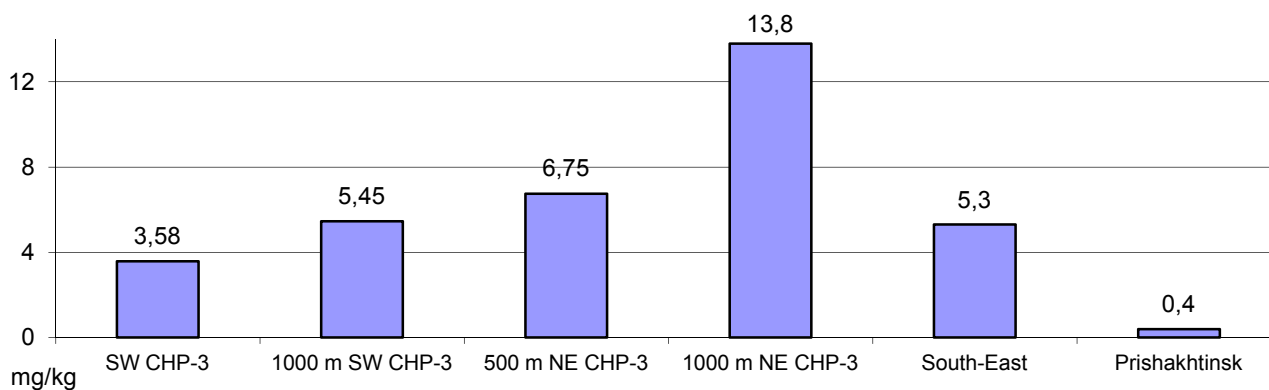
Figure 4. Iron content by areas of Karaganda

Iron plays the role of a catalyst in the formation of chlorophyll and is involved in the respiration of plants, being part of enzymes that regulate redox processes. Analysis of the iron content showed (Fig. 4) that in Maykuduk, 500 m south-west of CHP-3, the iron concentration was 3.58 mg/kg, 1000 m south-west of CHP-3 — 5.45 mg/kg, 500 m north-east of CHP-3 — 6.75 mg/kg, 1000 m north-east of CHP-3 — 13.8 mg/kg. In Southeast, Shakhterov Ave. — iron concentration was 5.3 mg/kg. In Prishakhtinsk, the iron content was within the normal range.
